**[Docket No. FAA-2021-0189; Project Identifier AD-2020-00645-R; Amendment 39-21875; AD 2021-26-16]**

**Airworthiness Directives; Various Restricted Category Helicopters**

**2021-26-16 Various Restricted Category Helicopters:** Amendment 39-21875; Docket No. FAA-2021-0189; Project Identifier AD-2020-00645-R.

This AD was prompted by multiple reports of failure of the main driveshaft. The

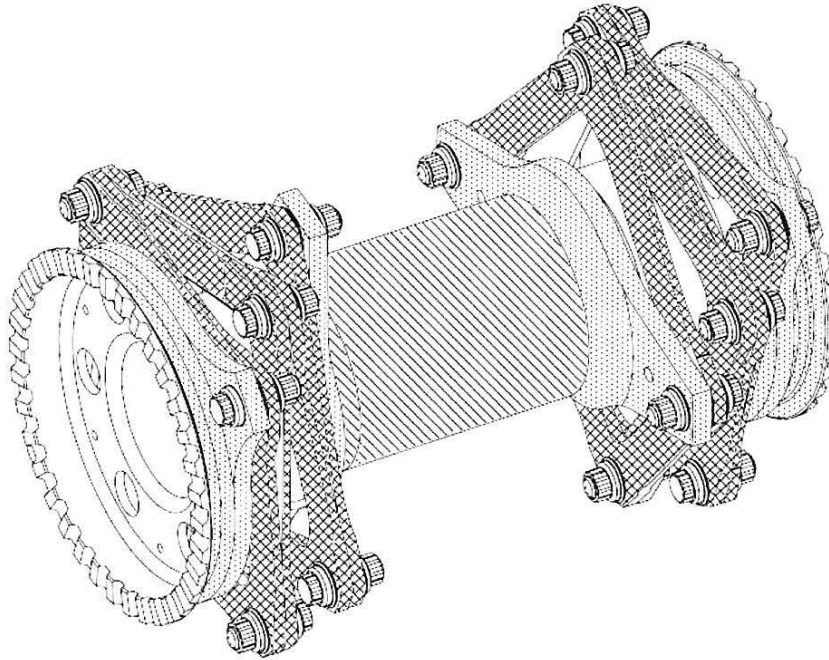
Figure 3 to Paragraph (g)(3)(iv) – Damage Limits

(iv) Inspect the main driveshaft for mechanical damage, corrosion, an edge dent, and nick as shown in Figure 3 to paragraph (g)(3)(iv) of this AD. For the purposes of this inspection, mechanical damage may be indicated by a crack, scratch, or wear; and corrosion may be indicated by corrosion or pitting. If there is a scratch, wear, corrosion, pitting, an edge dent, or a nick within allowable limits, before further flight, repair the main driveshaft in accordance with FAA-approved procedures. If there is a crack, or a scratch, wear, corrosion, pitting, an edge dent, or a nick that exceeds allowable limits, before further flight, replace the main driveshaft. The main drive shaft may be overhauled in accordance with FAA-approved procedures to accomplish the replacement required by this paragraph.

1. No cracks are permitted
2. Repairs must be no less than 1.000 inch apart.
3. Repairs not to be within 0.500 inches of bolt hole.
4. Faying surfaces must be free of any raised metal areas.
5. All repairs to be smooth at maximum depth and smoothly blended with surrounding surface.
6. Exposed bare metal may be touched up with Sermetel Product 1122 or 196. Zinc Chromate, primer color T, even though it does not blend cosmetically with Sermetel coating, can be used if Sermetel touch-up products are unavailable.
